SMALL SCALE WASTE MANAGEMENT PROJECT

Wisconsin Mound Performance

James C. Converse and E. Jerry Tyler

1986

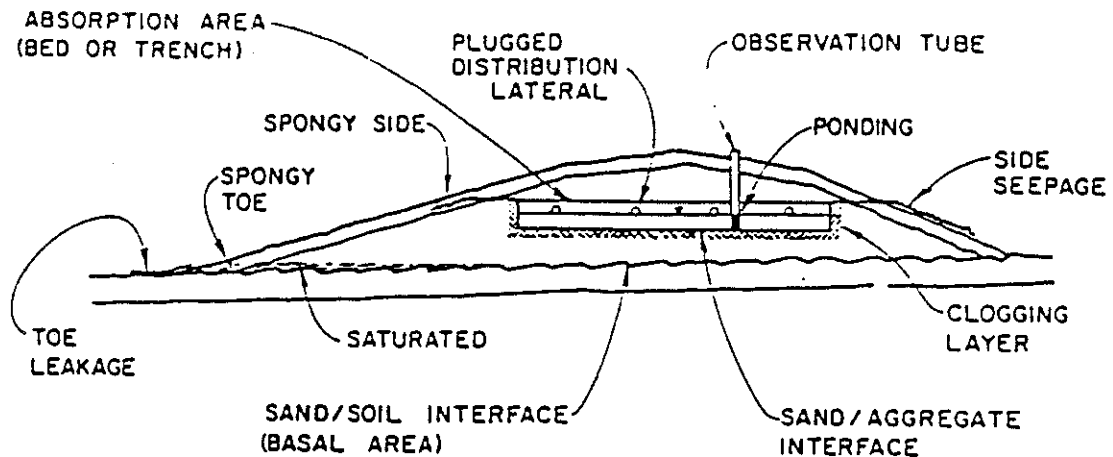
Figure 3. Cross section of Wisconsin Mound Showing Potential Problems.

Spongy side: On occasion a spongy or soft area will occur on the side of the mound near the absorption area (Fig. 3). This indicates that the soil is near saturation and there is undoubtedly ponded effluent in the absorption area.

Spongy toe: A spongy or soft area may occur at the toe of the mound (Fig. 3). The sand fill in the mound near the toe is saturated indicating either insufficient basal area, too large a linear loading rate, or possibly wet weather conditions. Depending upon circumstances toe leakage may occur. (Converse and Tyler, 1985a, 1985b; and Tyler and Converse, 1985).
