SIPHONS FOR ON-SITE SYSTEMS
LAB AND FIELD EVALUATION

Glenn M. Falkowski

James C. Converse

Presented at the 5th Northwest Wastewater Treatment Short Course on Site Wastewater Treatment: Environmental Significance, Seattle, WA, September 10 & 11, 1985.

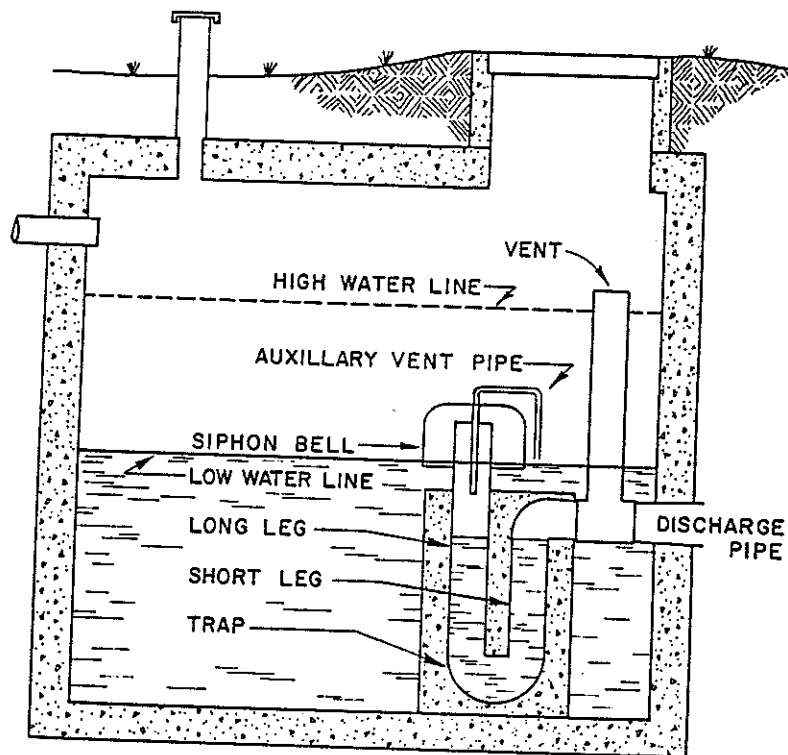
A typical cross section of a dosing tank and siphon assembly is shown to identify the various components (Fig. 1). The trap must be filled with water initially after installation.

Fig. 1 Typical Cross Section of a Dosing Chamber Containing a Siphon. This Figure Shows Most Beneficial Placement of Tank Opening in Relation to Siphon and Vent Pipe for Operational Observation

The tank should be set up in such a way as to locate the opening above the siphon and overflow pipe. This greatly facilitates observation of siphon performance.

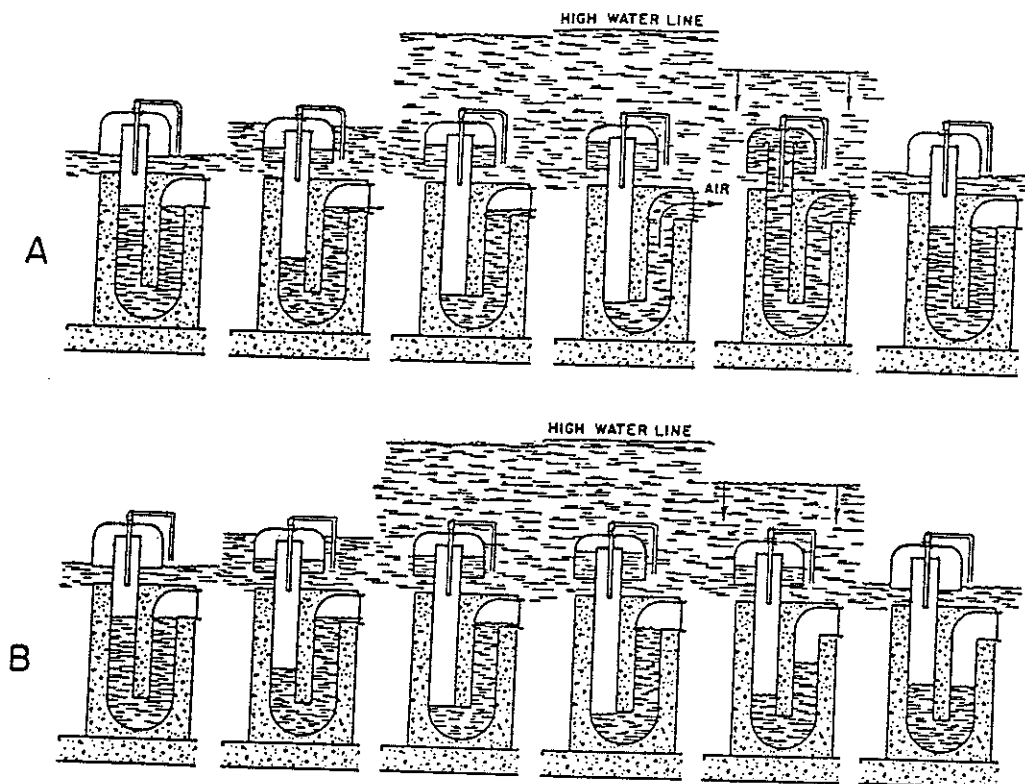
As the effluent level begins to rise in the tank, it reaches the auxillary vent opening, effecting a seal and trapping the proper volume of air in the bell to maintain balance with the water in the trap (Fig. 2A). As the

effluent continues to rise, the air under the bell is compressed and begins to force the water from the trap into the discharge pipe. When the long leg of the trap is completely filled with air, a small rise in the effluent level of the tank causes air to escape into the short leg, disrupting the equilibrium and causing the siphon to activate. The level of effluent in the tank drops until the bottom of the bell is reached, sucking air and breaking the siphon action, at which point the cycle starts over.

For larger systems, two or more siphons of the same size can be placed in the same tank to provide greater flexibility by discharging into separate distribution systems. As in a single siphon, the traps must be initially filled with water (Fig. 2). The stages of operation are the same as for a single siphon and due to slight variation one of the siphons will activate (Siphon A in Fig. 2). When the siphon action is broken, the first trap will be re-filled, but the other trap, having been partially emptied, will have less water in its trap (Siphon B in Fig. 2). This second siphon will then discharge during the next cycle because of the smaller plug of water in its trap.

Fig. 2 Schematic of Siphon Showing Effluent Location in Trap in Relation to Liquid Level in Tank (A). Effluent Location of Alternating Siphons, Siphon A Activating (A&B).

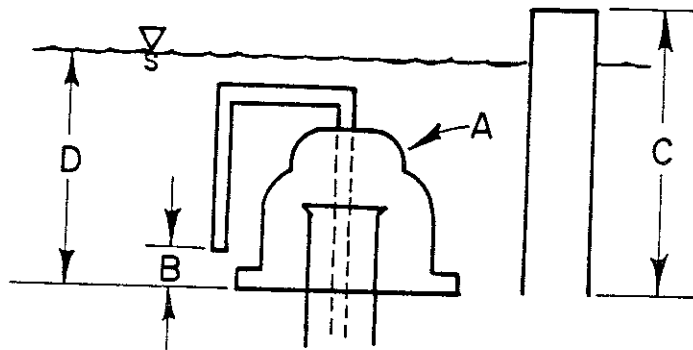
The field study consisted of monitoring a number of actual systems throughout southern Wisconsin. At each site a series of measurements were taken to relate siphon specifications with operation (Fig. 3). When available, sufficient water was added to activate the siphon and determine proper operation. If sufficient water was not accessible, a 10 gal. (38 L) container of water was emptied into the tank and this new level was recorded. After 15 minutes the level was again measured and compared to the previous reading. If the two readings were the same, the siphon was considered to be working. If the vent pipe was located beneath the tank opening, it was possible to directly determine if the system was trickling by watching for a significant amount of effluent flowing out to the distribution system. When a siphon was found to be trickling, air was blown under the bell with a "J"-shaped tube to recharge it.

Fig. 3 Schematic Showing Measurements Taken at Each Site with Distances Measured from Bell Bottom
A) Size of the bell
B) Distance to the Auxillary Vent Opening
C) Distance to Vent Opening
D) Distance to Water

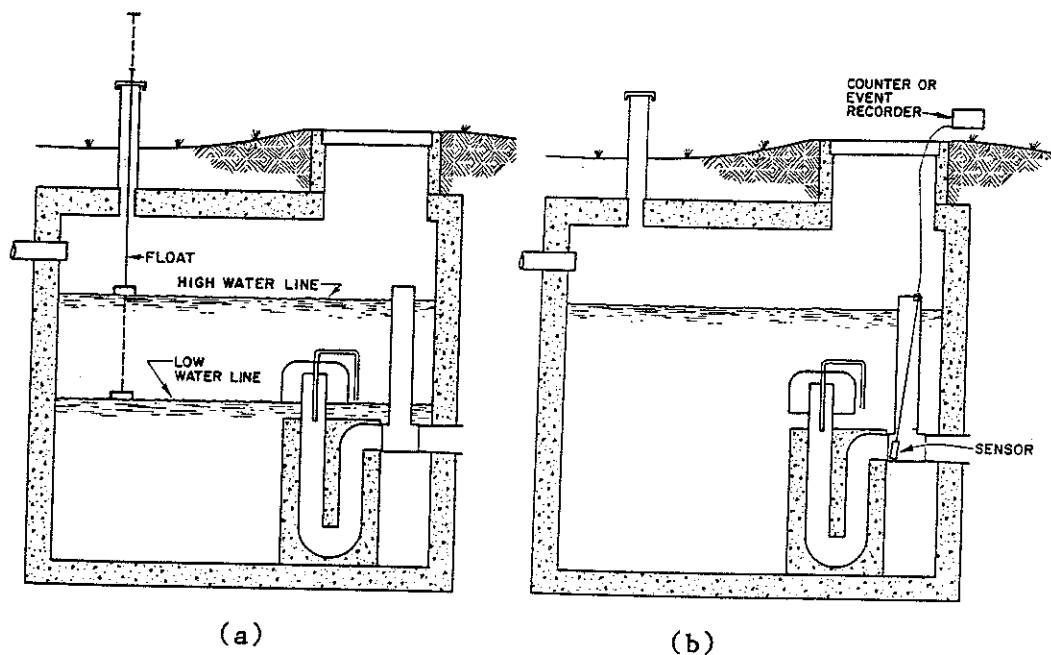
Fig. 4 Schematic of Siphon Tank Showing Possible Monitoring Devices for: a) Single siphon b) Alternating siphon

Siphons can begin to trickle for no apparent reason, and if not corrected, can cause plugging of the distribution system. The homeowner must be told that they should be checked periodically. An inexpensive and simple method of monitoring the system is with a float device (Figure 4a). The float will move up slowly with the tank level and then quickly move down during the discharge. If the float oscillates in the center of travel, the siphon should be reported for maintenance.

A monitoring device should be required for alternating systems to prevent overloading if one siphon should malfunction. A float system will not work on an alternating system, but a recorder system such as shown in Figure 4b will work satisfactorily.
