## **Causes of the failure of the Costco bioretention systems and its remediation**

Phillip Barak, PhD  
Professor, Dept of Soil Science  
University of Wisconsin-Madison  
12 Sep 2012

# Sodicity Issues in Stormwater Infiltration Basins

# Saline and Sodic Soils in Wisconsin: The Sad Story of the Costco Infiltration Pond

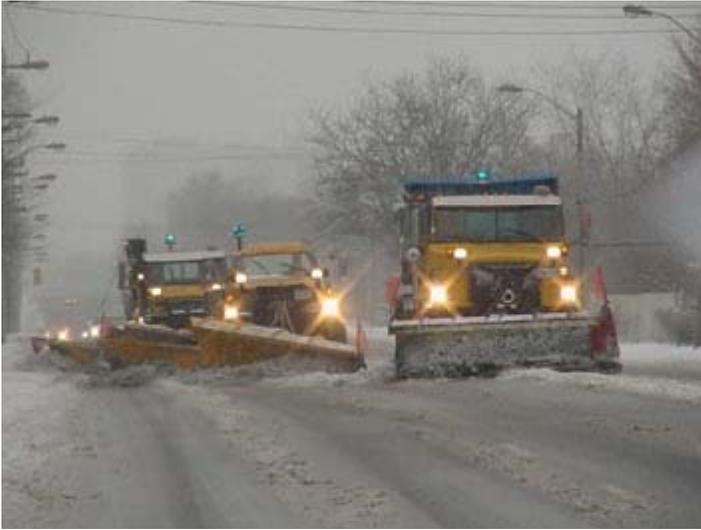
Annual Madison salt application:  
10 – 25 tons/mile  
(Goal: 6 tons/mile)

Tons of salt applied or purchased by municipality, winter of 2008/9:

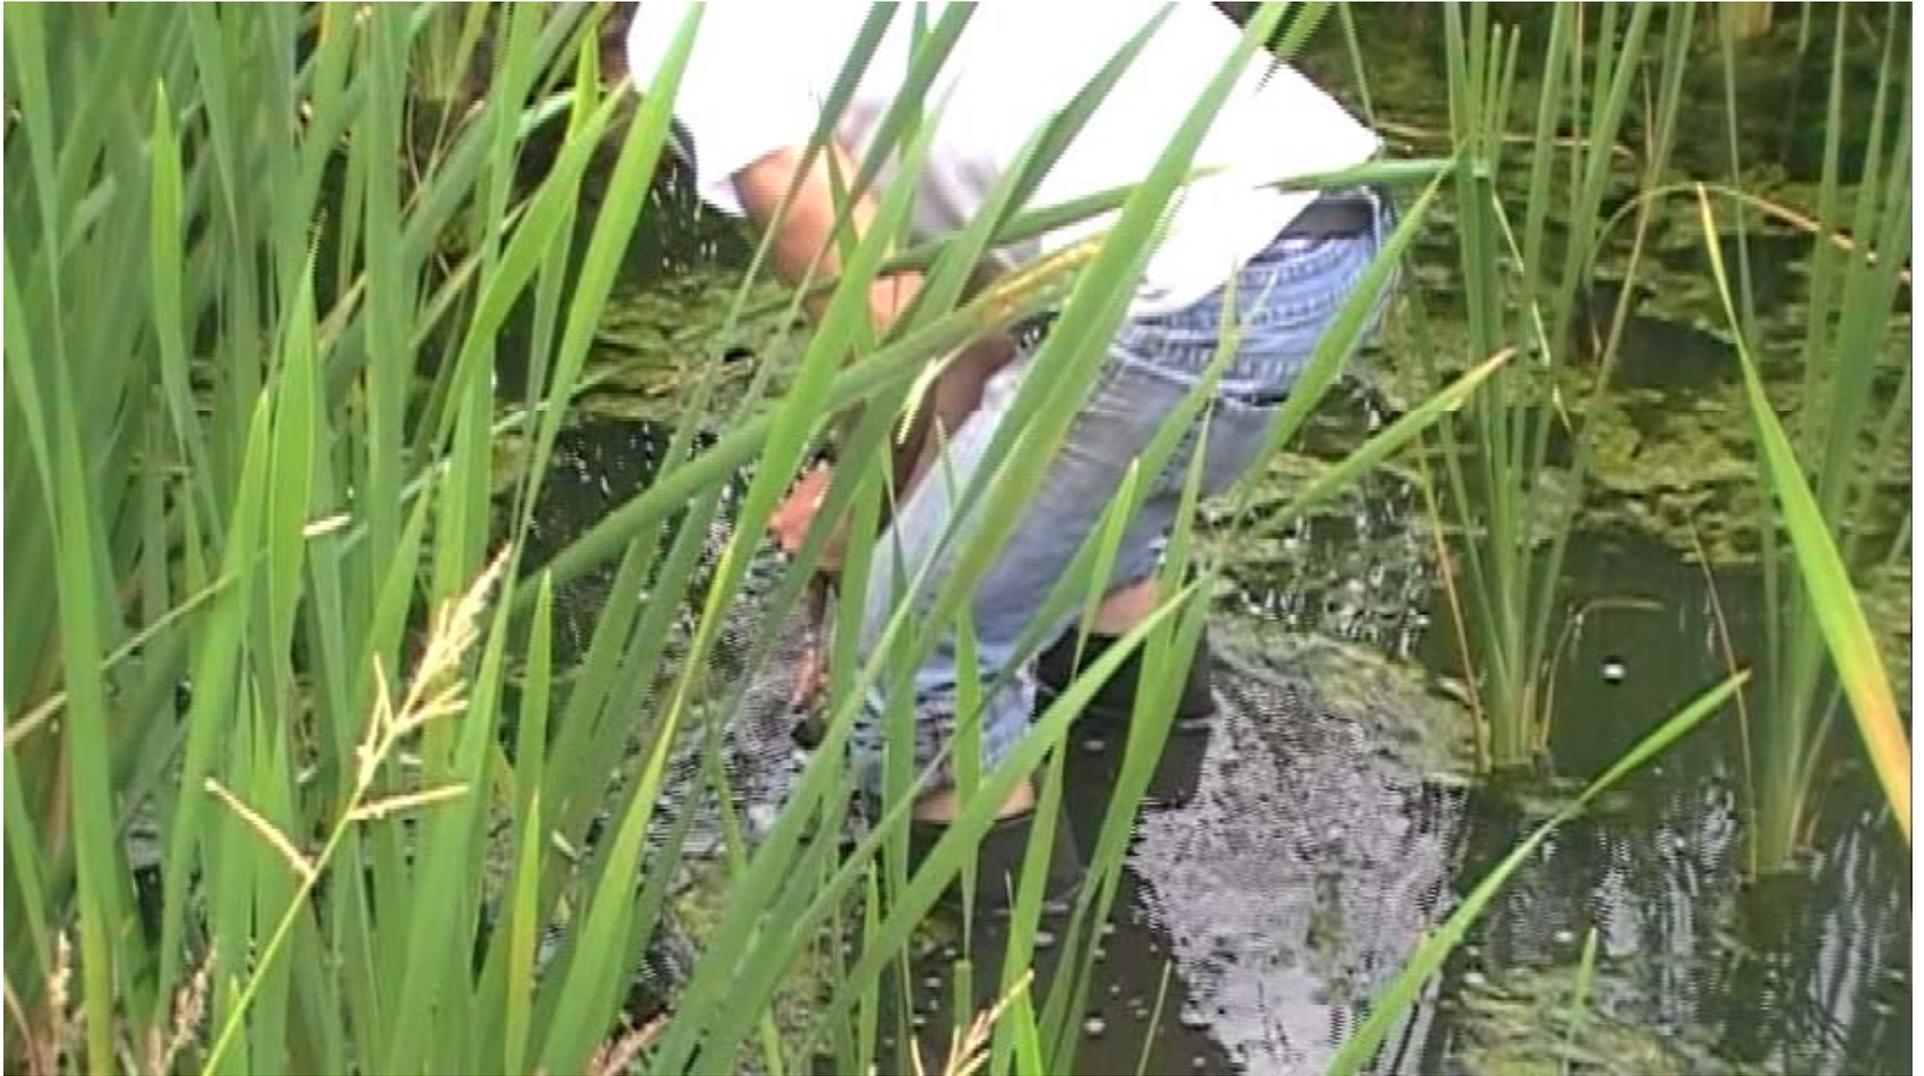
Sampling at Costco retention ponds, Aug 2010

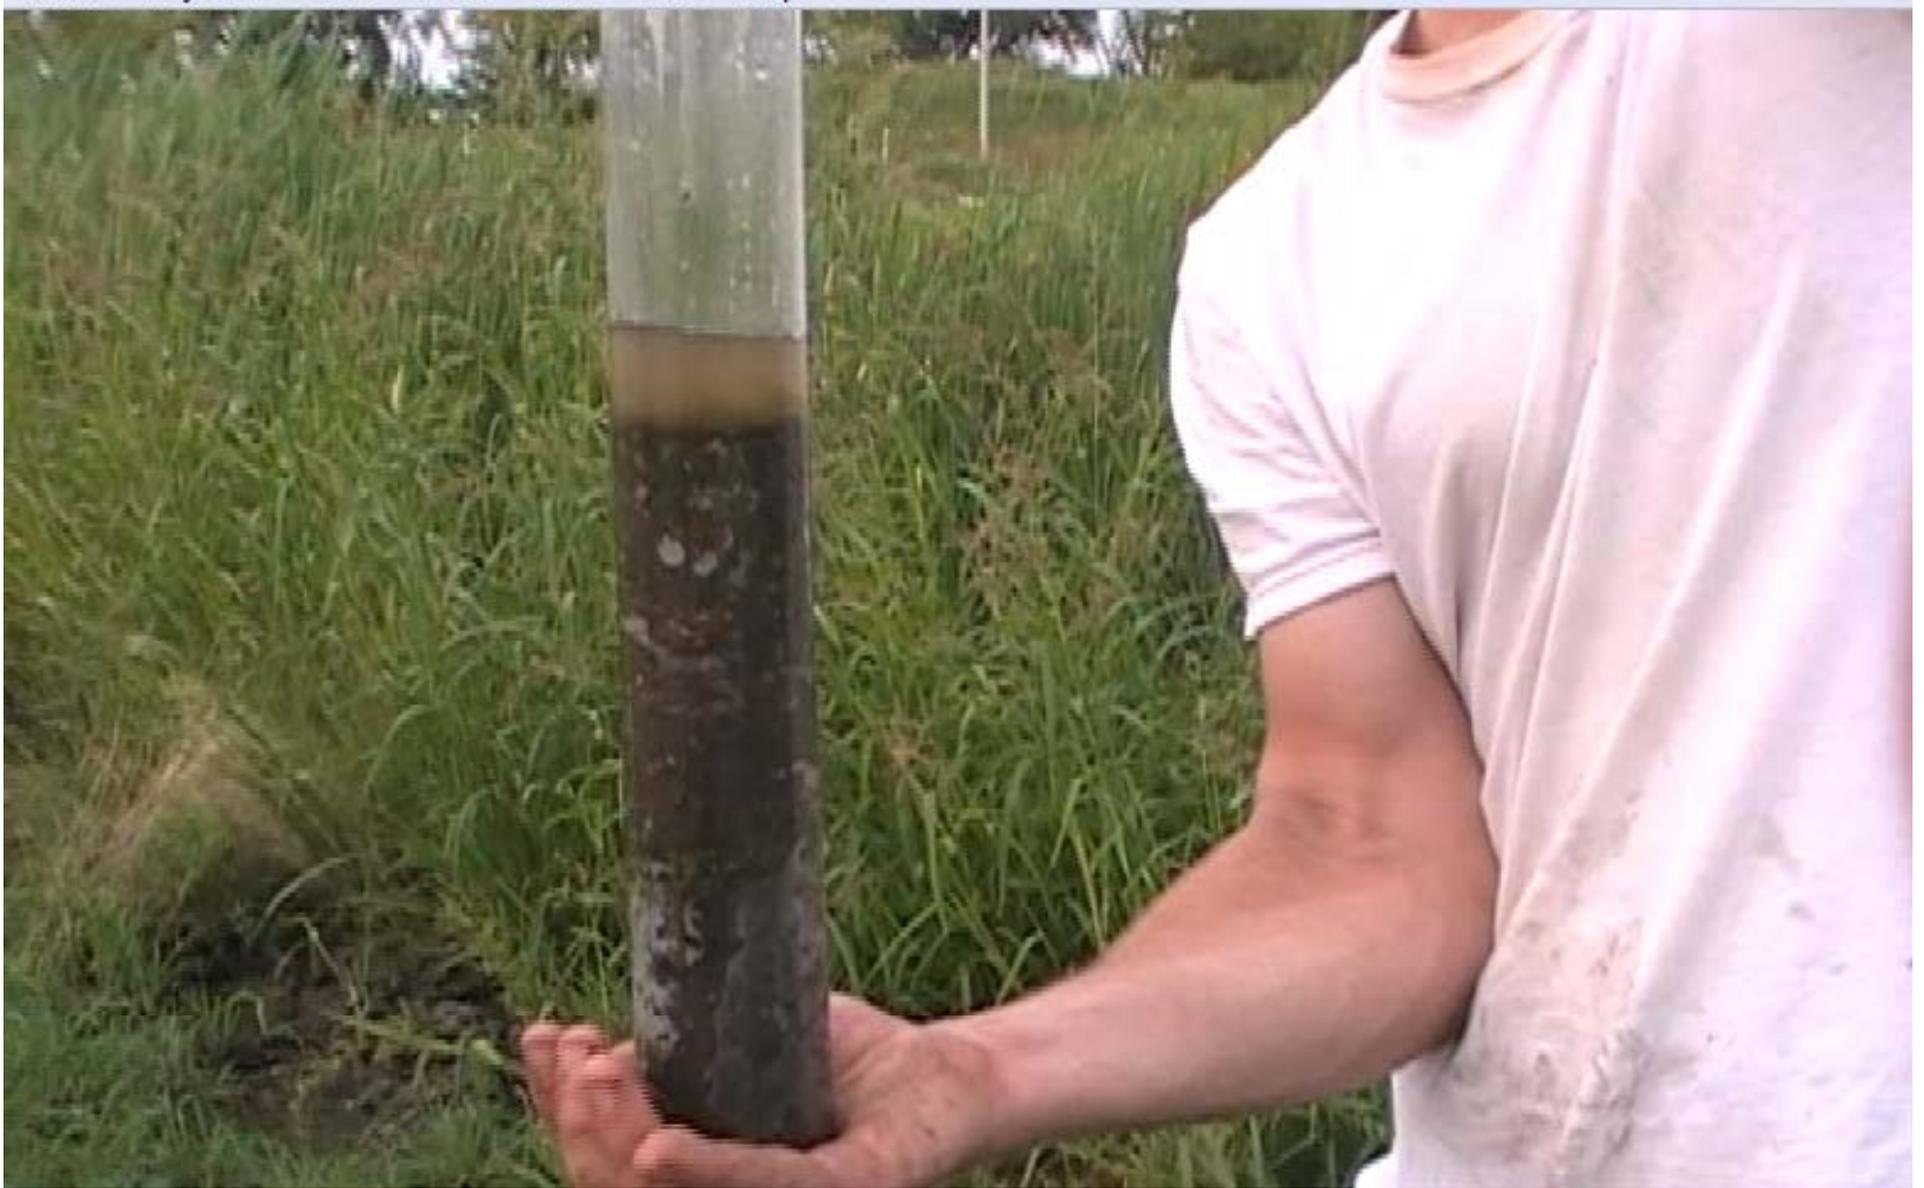
Collection of cores from retention ponds (in background).

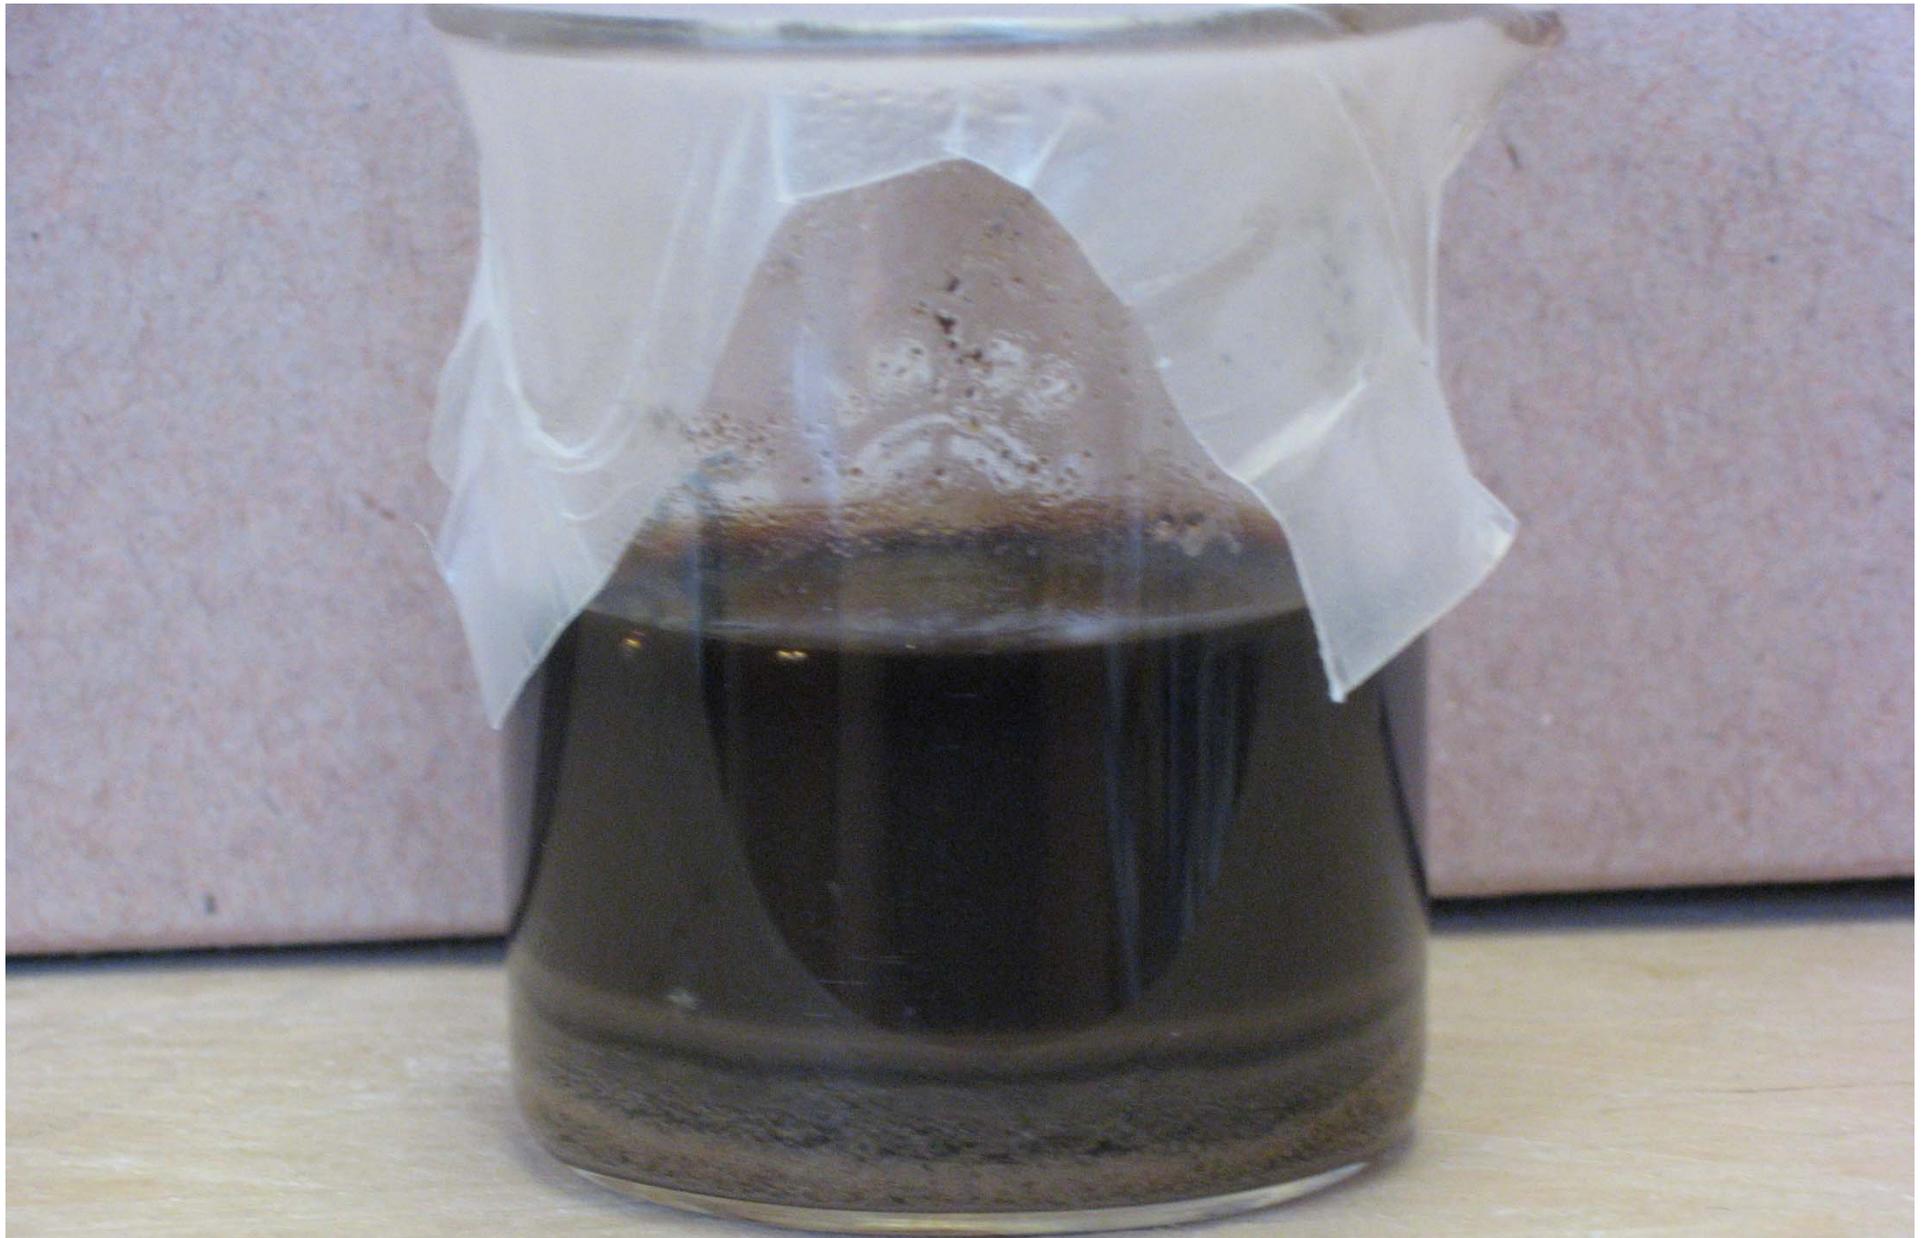
Dispersion of 1-cm core segments in 1% sodium polyphosphate and mechanical agitation, here allowed to settle showing bands of sand, silt and suspended clay, for particle size determination by laser scattering—after removal of pea gravel by sieving.

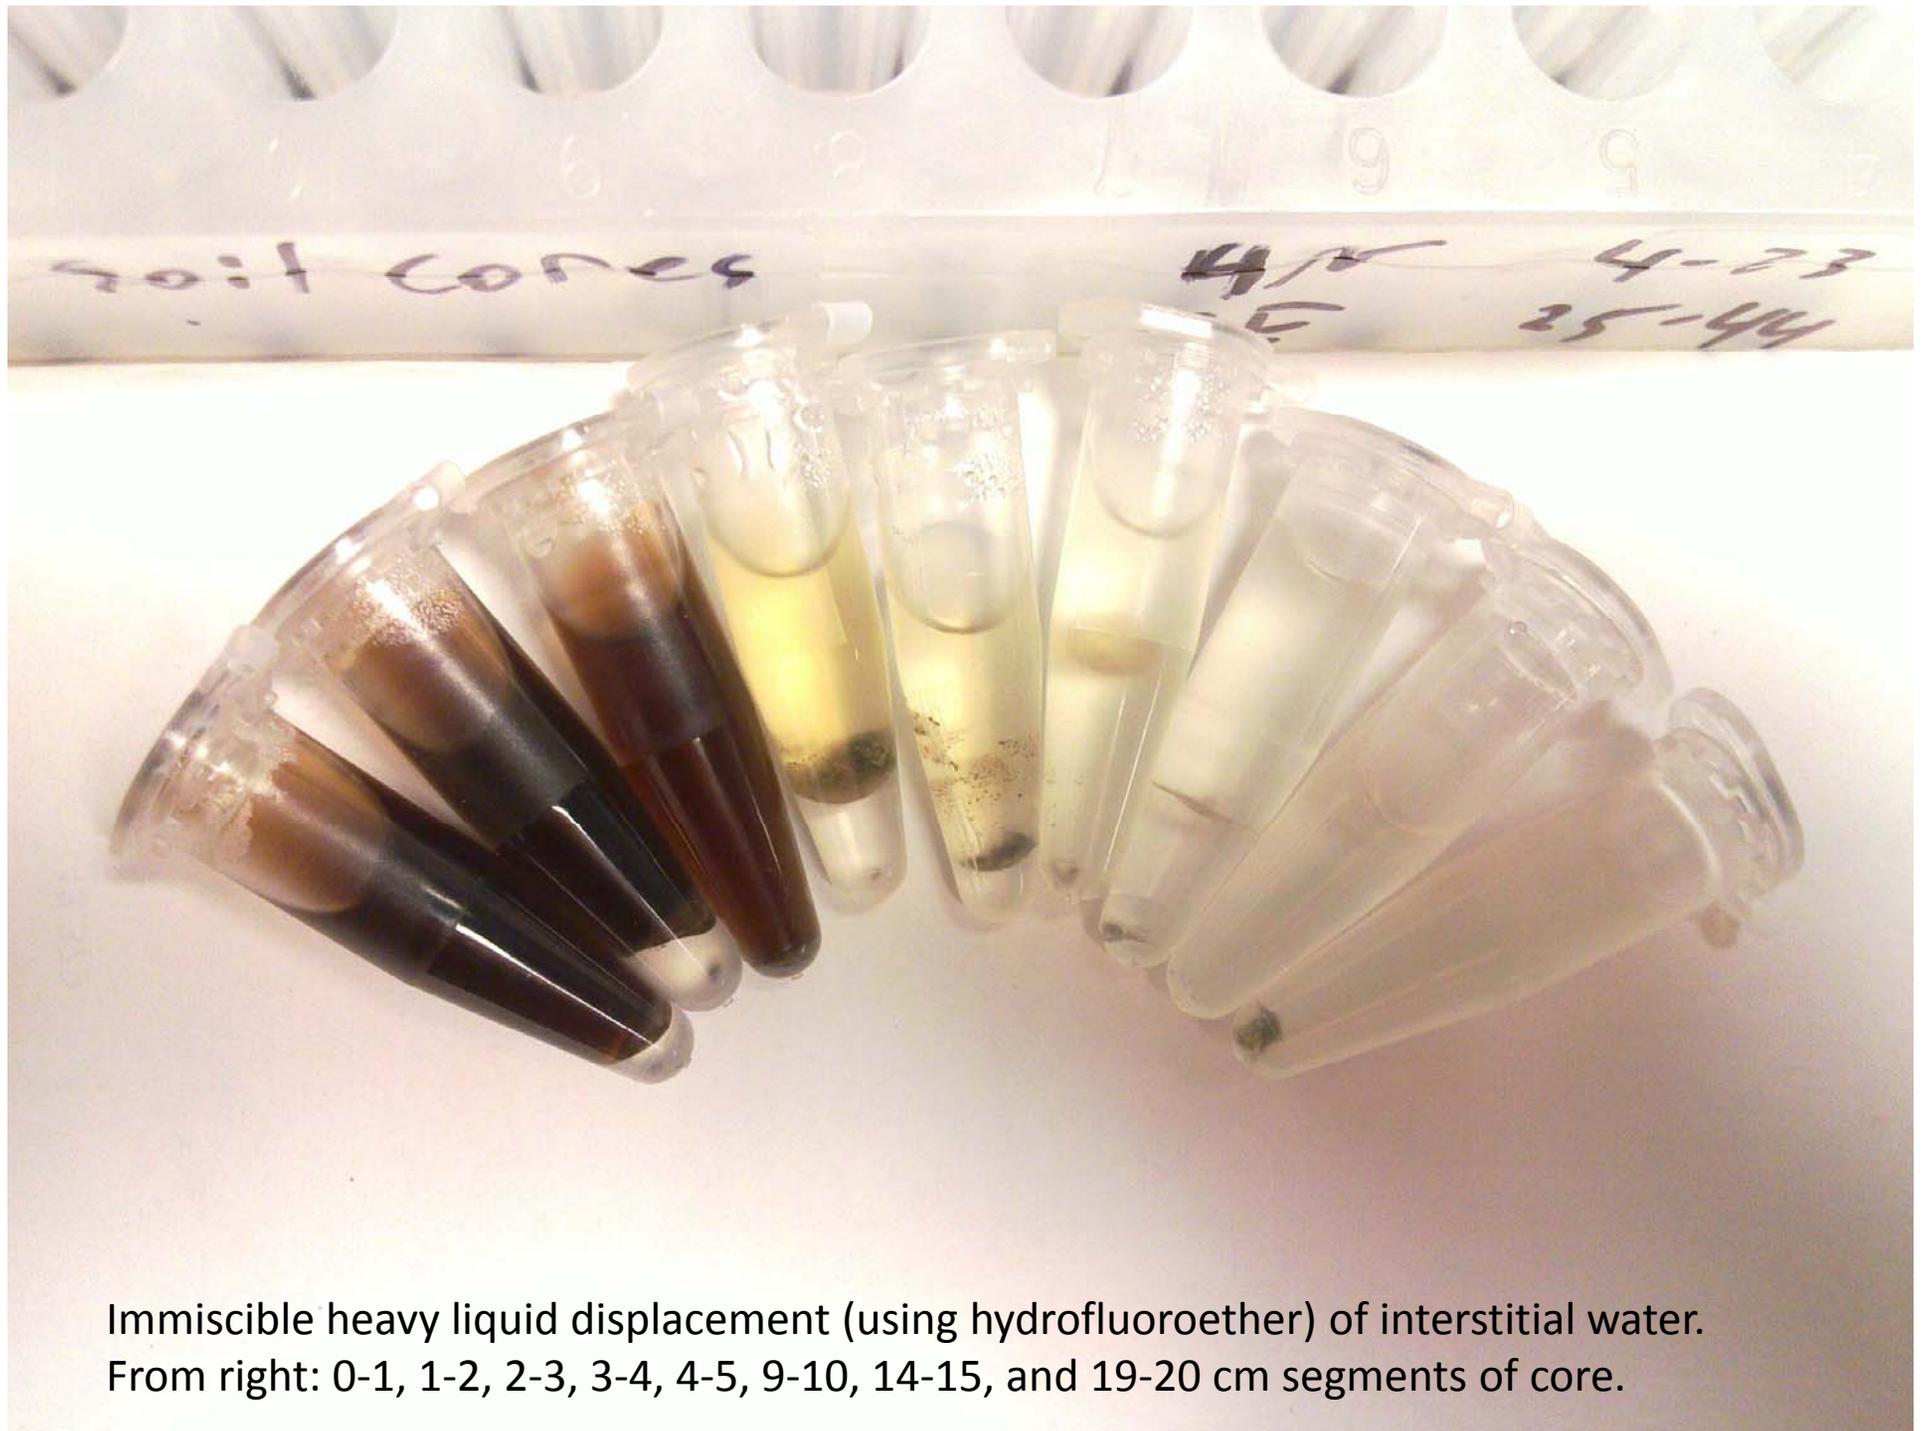
Immiscible heavy liquid displacement (using hydrofluoroether) of interstitial water.  
From right: 0-1, 1-2, 2-3, 3-4, 4-5, 9-10, 14-15, and 19-20 cm segments of core.

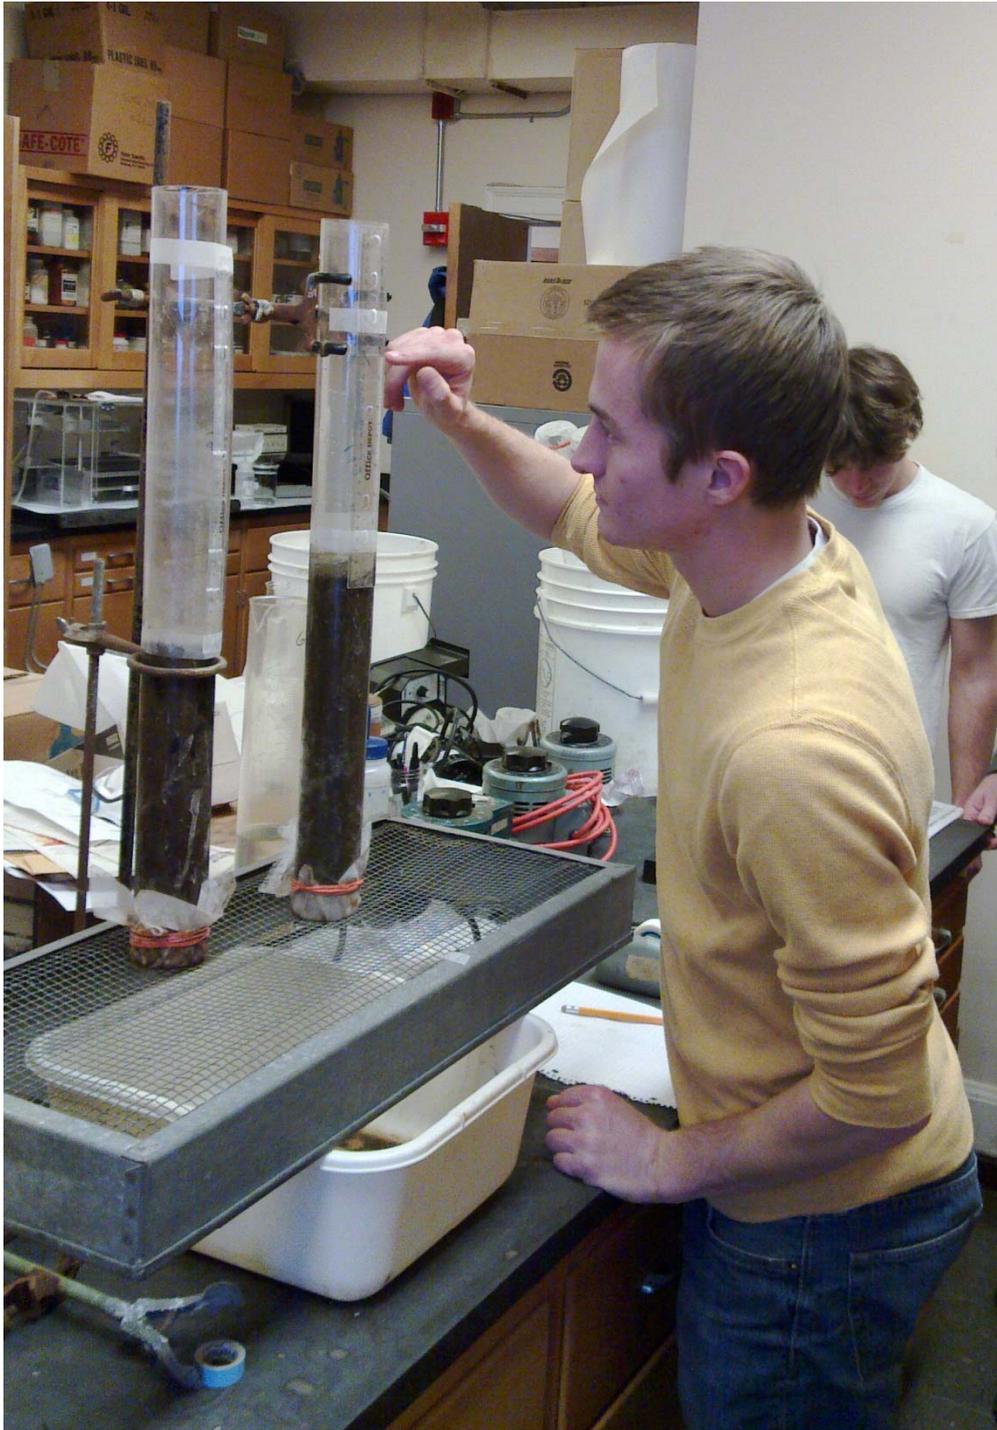
Falling head permeameter  
to measure  $K_{\text{sat}}$  on intact cores, using  
sequence of:

- tap water,
- gypsum-saturated water, and
- 25 mM calcium chloride
- 250 mM calcium chloride

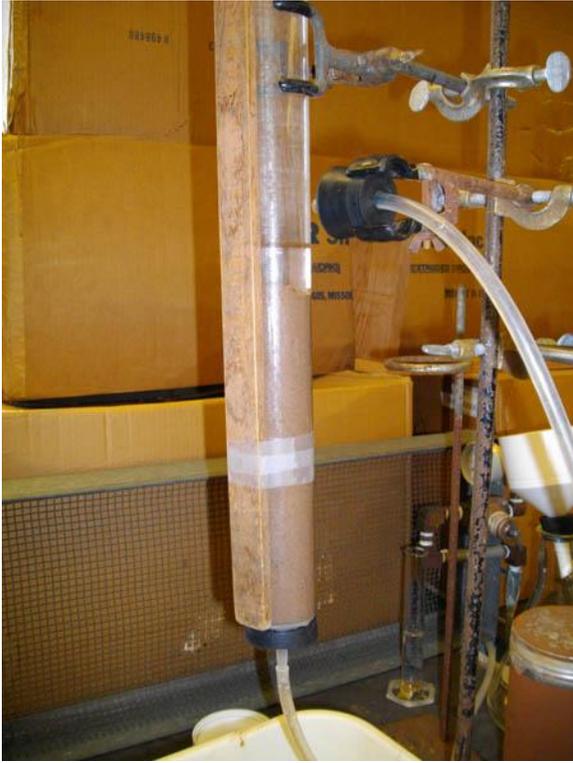
**Figure 1: Permeameter Setup**

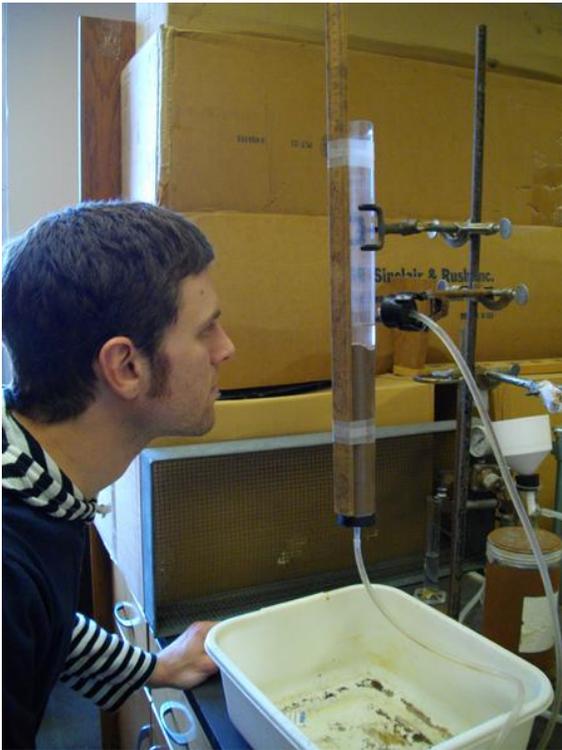
**Figure 2: Measuring Hydraulic Conductivity**

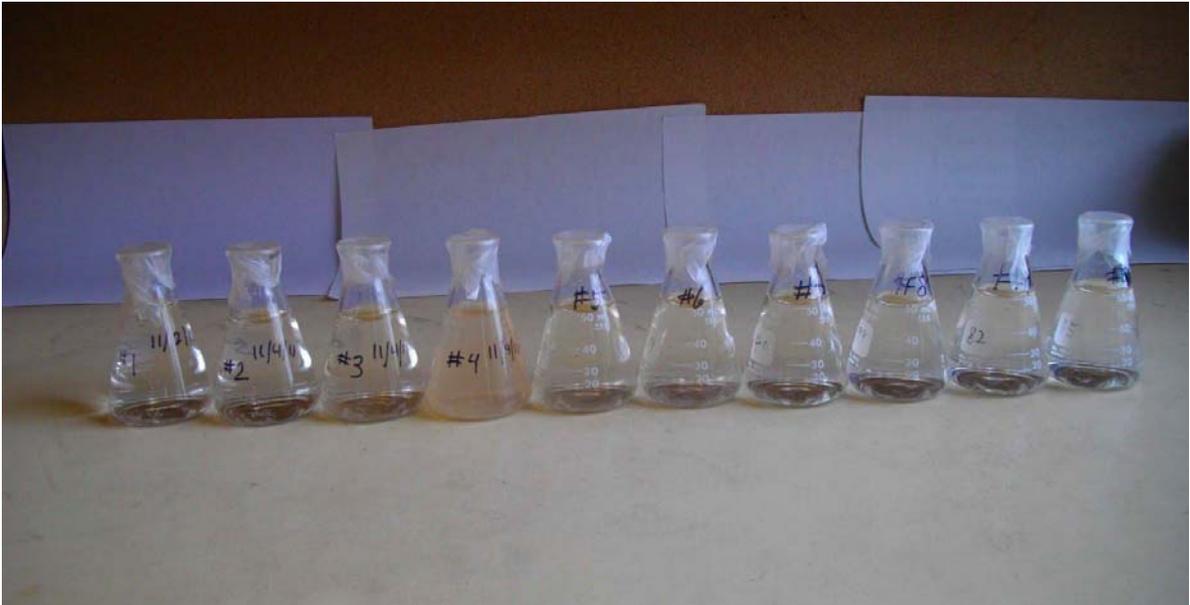
**Figure 5:** Photo of water samples 1-10 from representing 4 pore volumes of effluent from Series A.

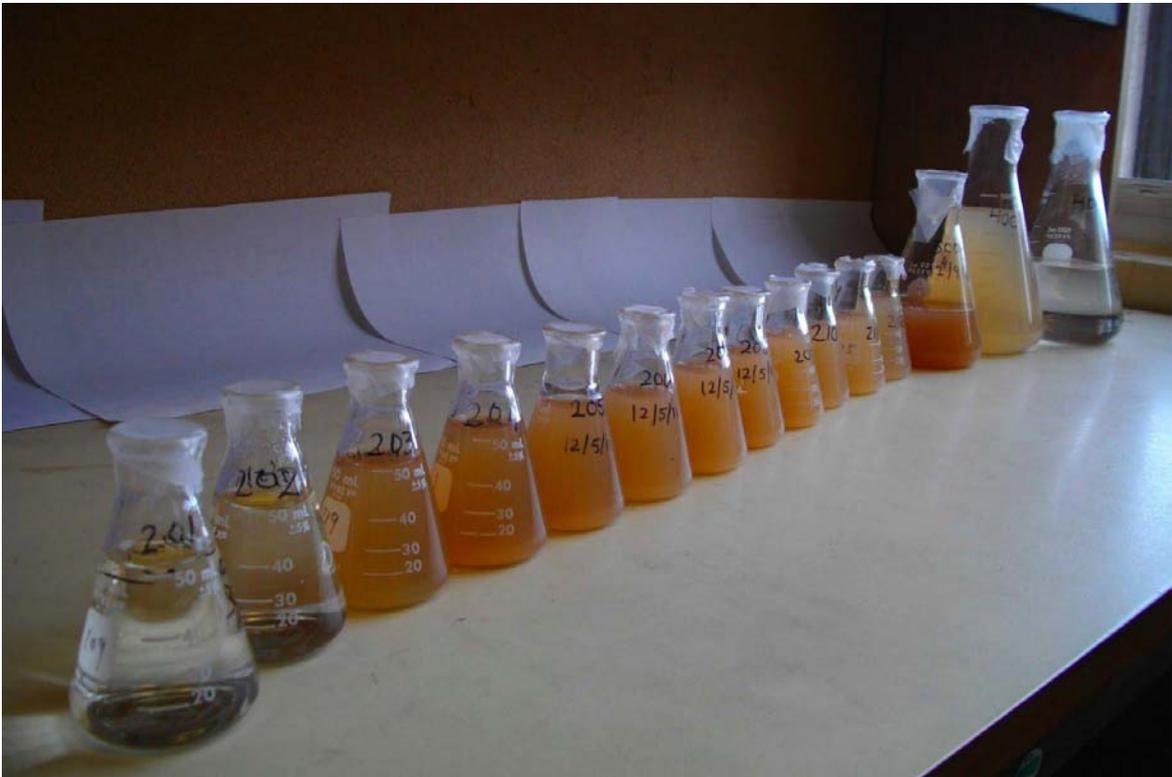
**Figure 6:** Photo of water samples 201-212, 300, 400, 401 representing 13 pore volumes of effluent from Series B.

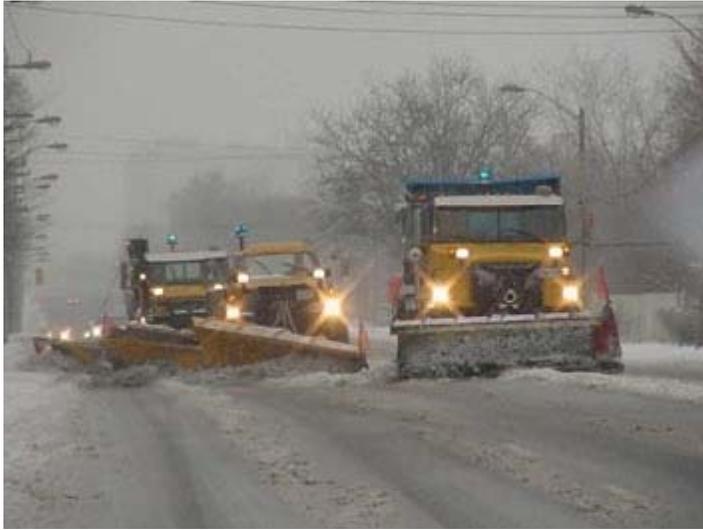
Annual Madison salt application:  
10 – 25 tons/mile  
(Goal: 6 tons/mile)

Tons of salt applied or purchased by municipality, winter of 2008/9:

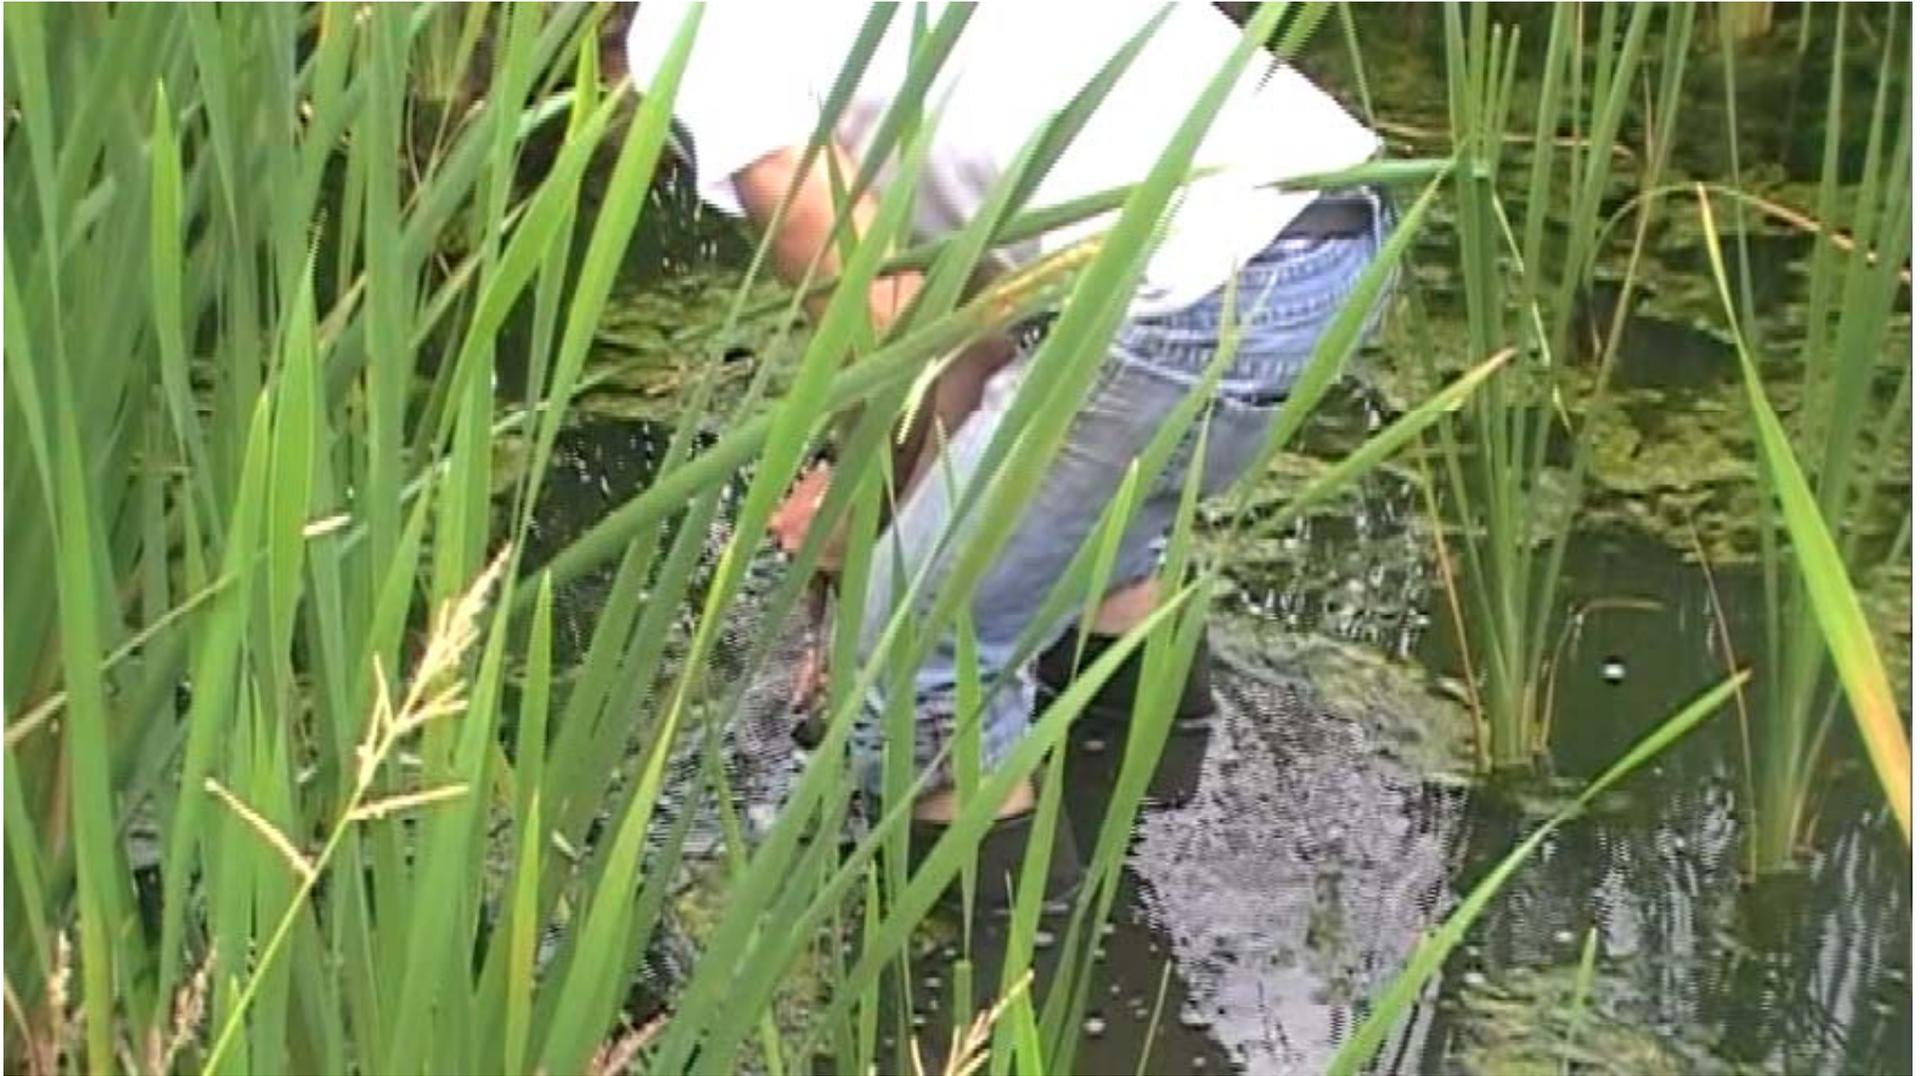
Sampling at retention ponds, Aug 2010

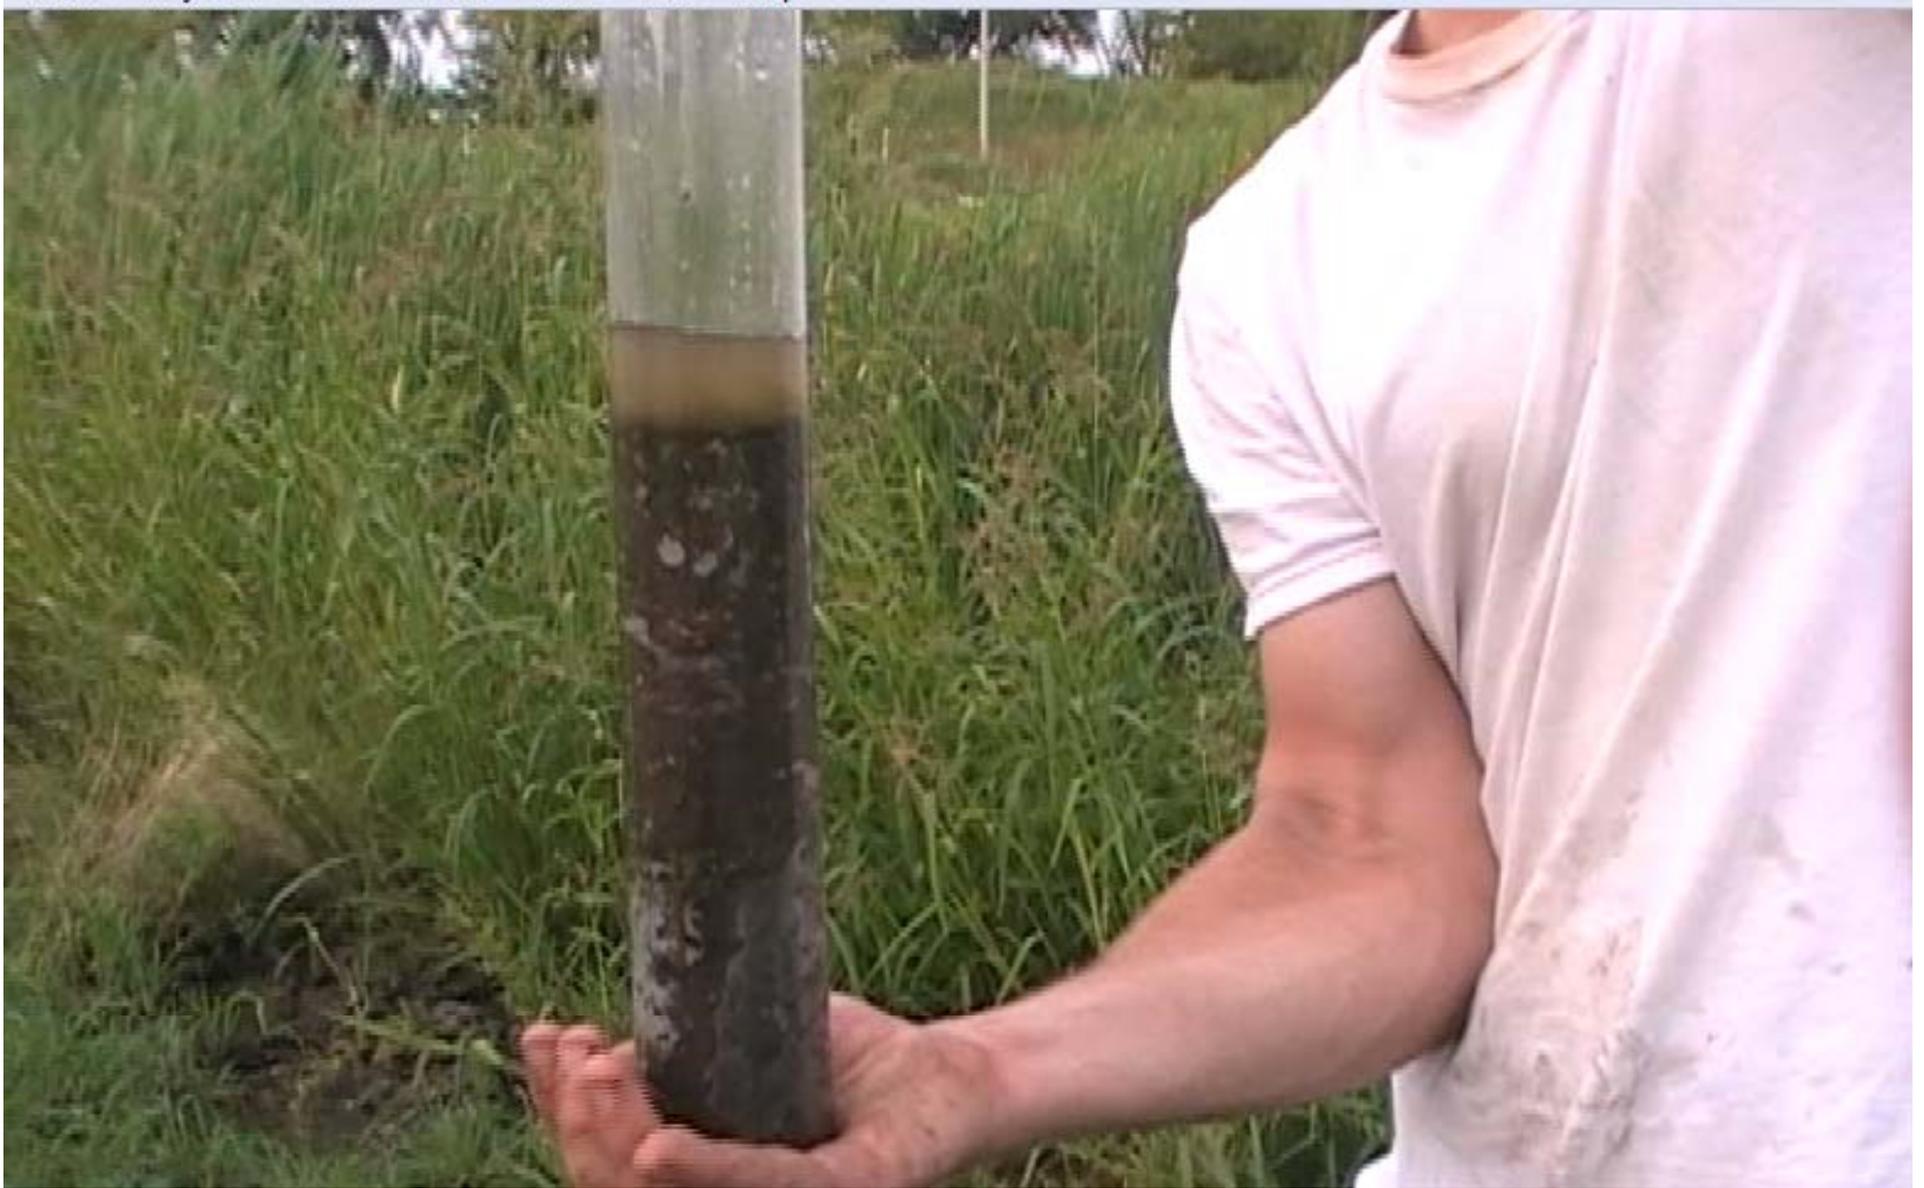
Collection of cores from retention ponds (in background).

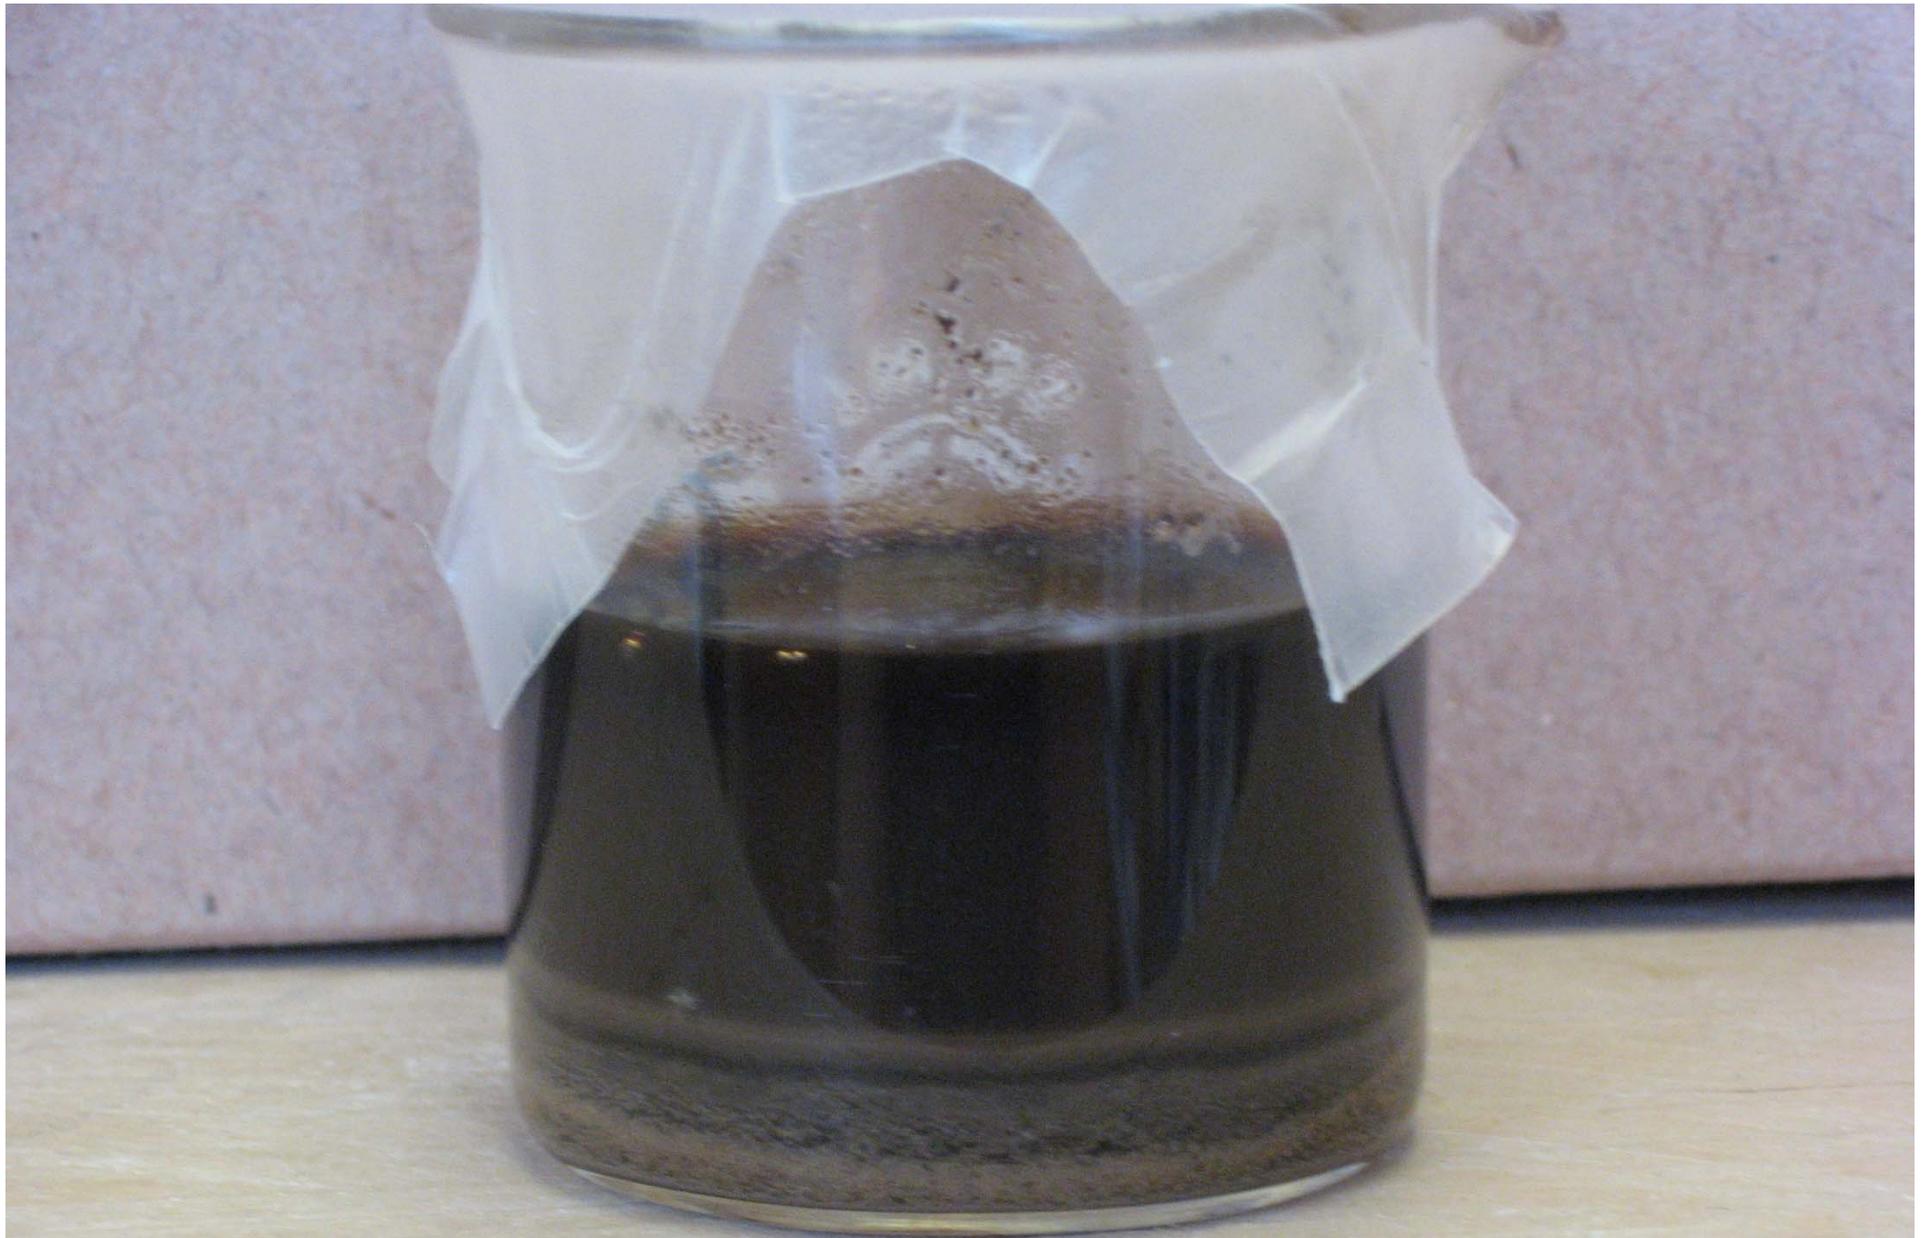
Dispersion of 1-cm core segments in 1% sodium polymetaphosphate and mechanical agitation, here allowed to settle showing bands of sand, silt and suspended clay, for particle size determination by laser scattering—after removal of pea gravel by sieving.

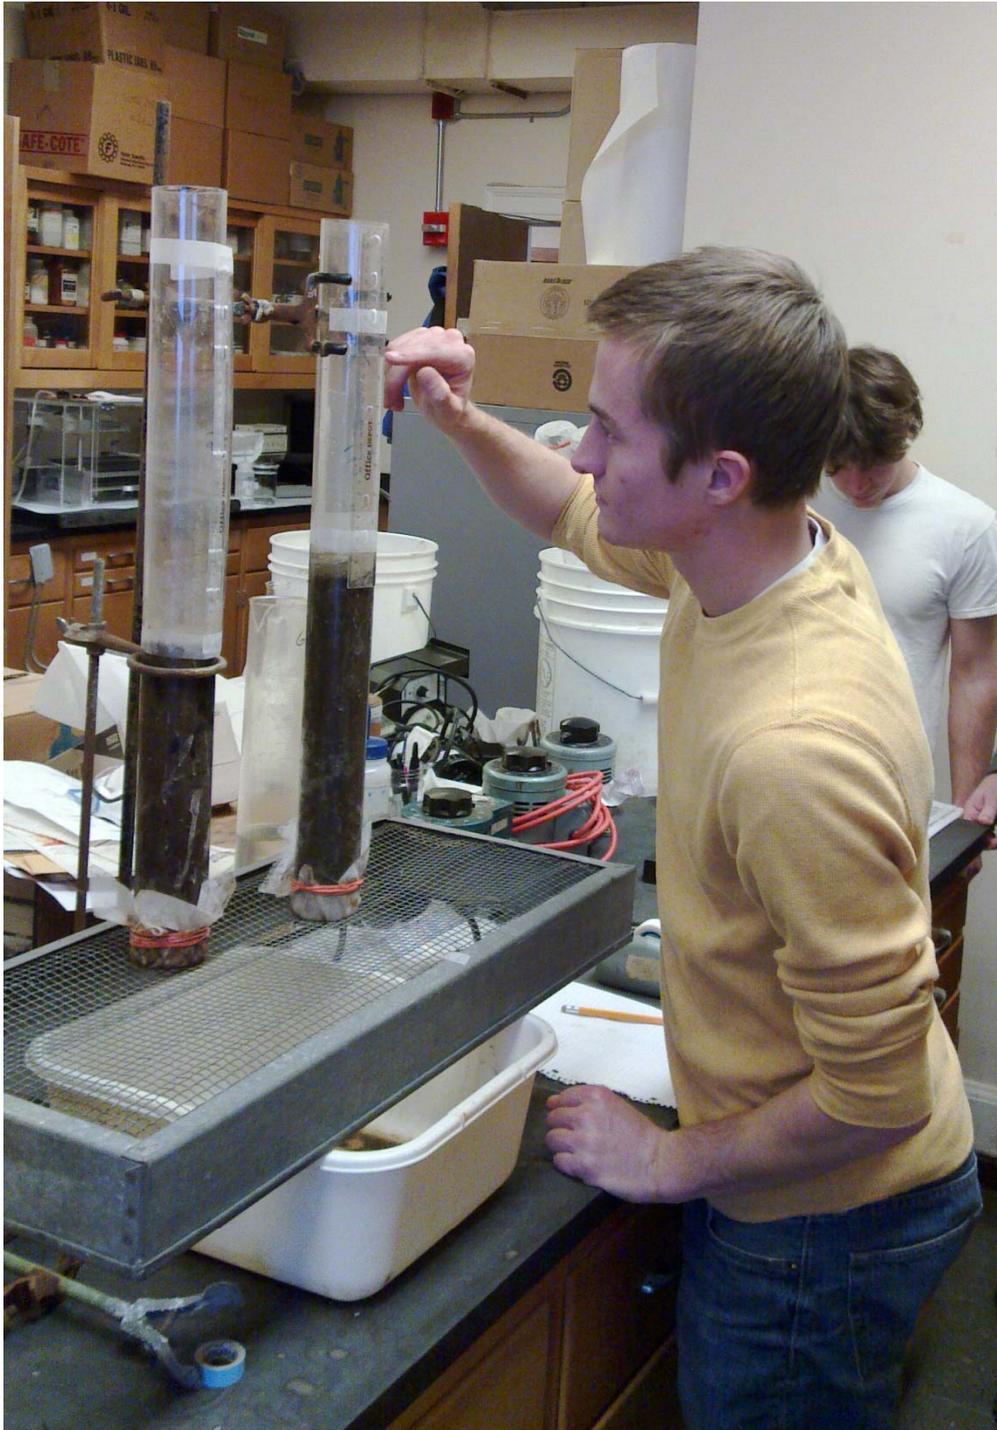
Falling head permeameter  
to measure  $K_{\text{sat}}$  on intact cores, using  
sequence of:

- tap water,
- gypsum-saturated water, and
- 25 mM calcium chloride
