## **Causes of the failure of the Costco bioretention systems and its remediation**

Phillip Barak, PhD  
Professor, Dept of Soil Science  
University of Wisconsin-Madison  
12 Sep 2012

# Sodicity Issues in Stormwater Infiltration Basins

# Saline and Sodic Soils in Wisconsin: The Sad Story of the Costco Infiltration Pond

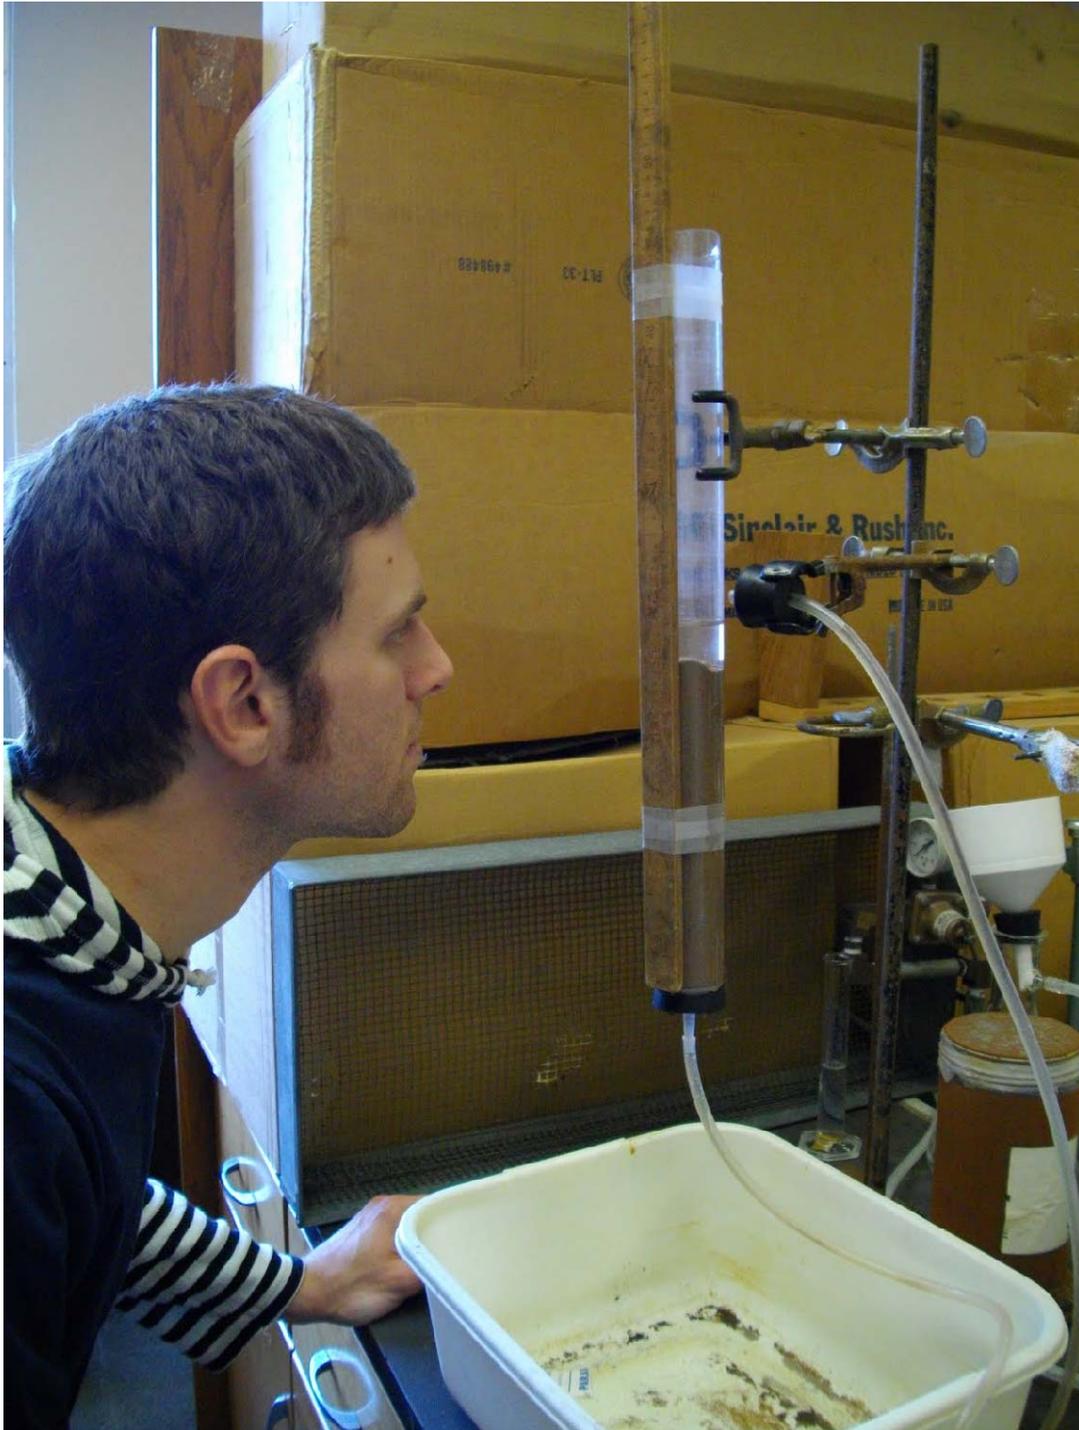
Engineered soil, sand, <5% clay

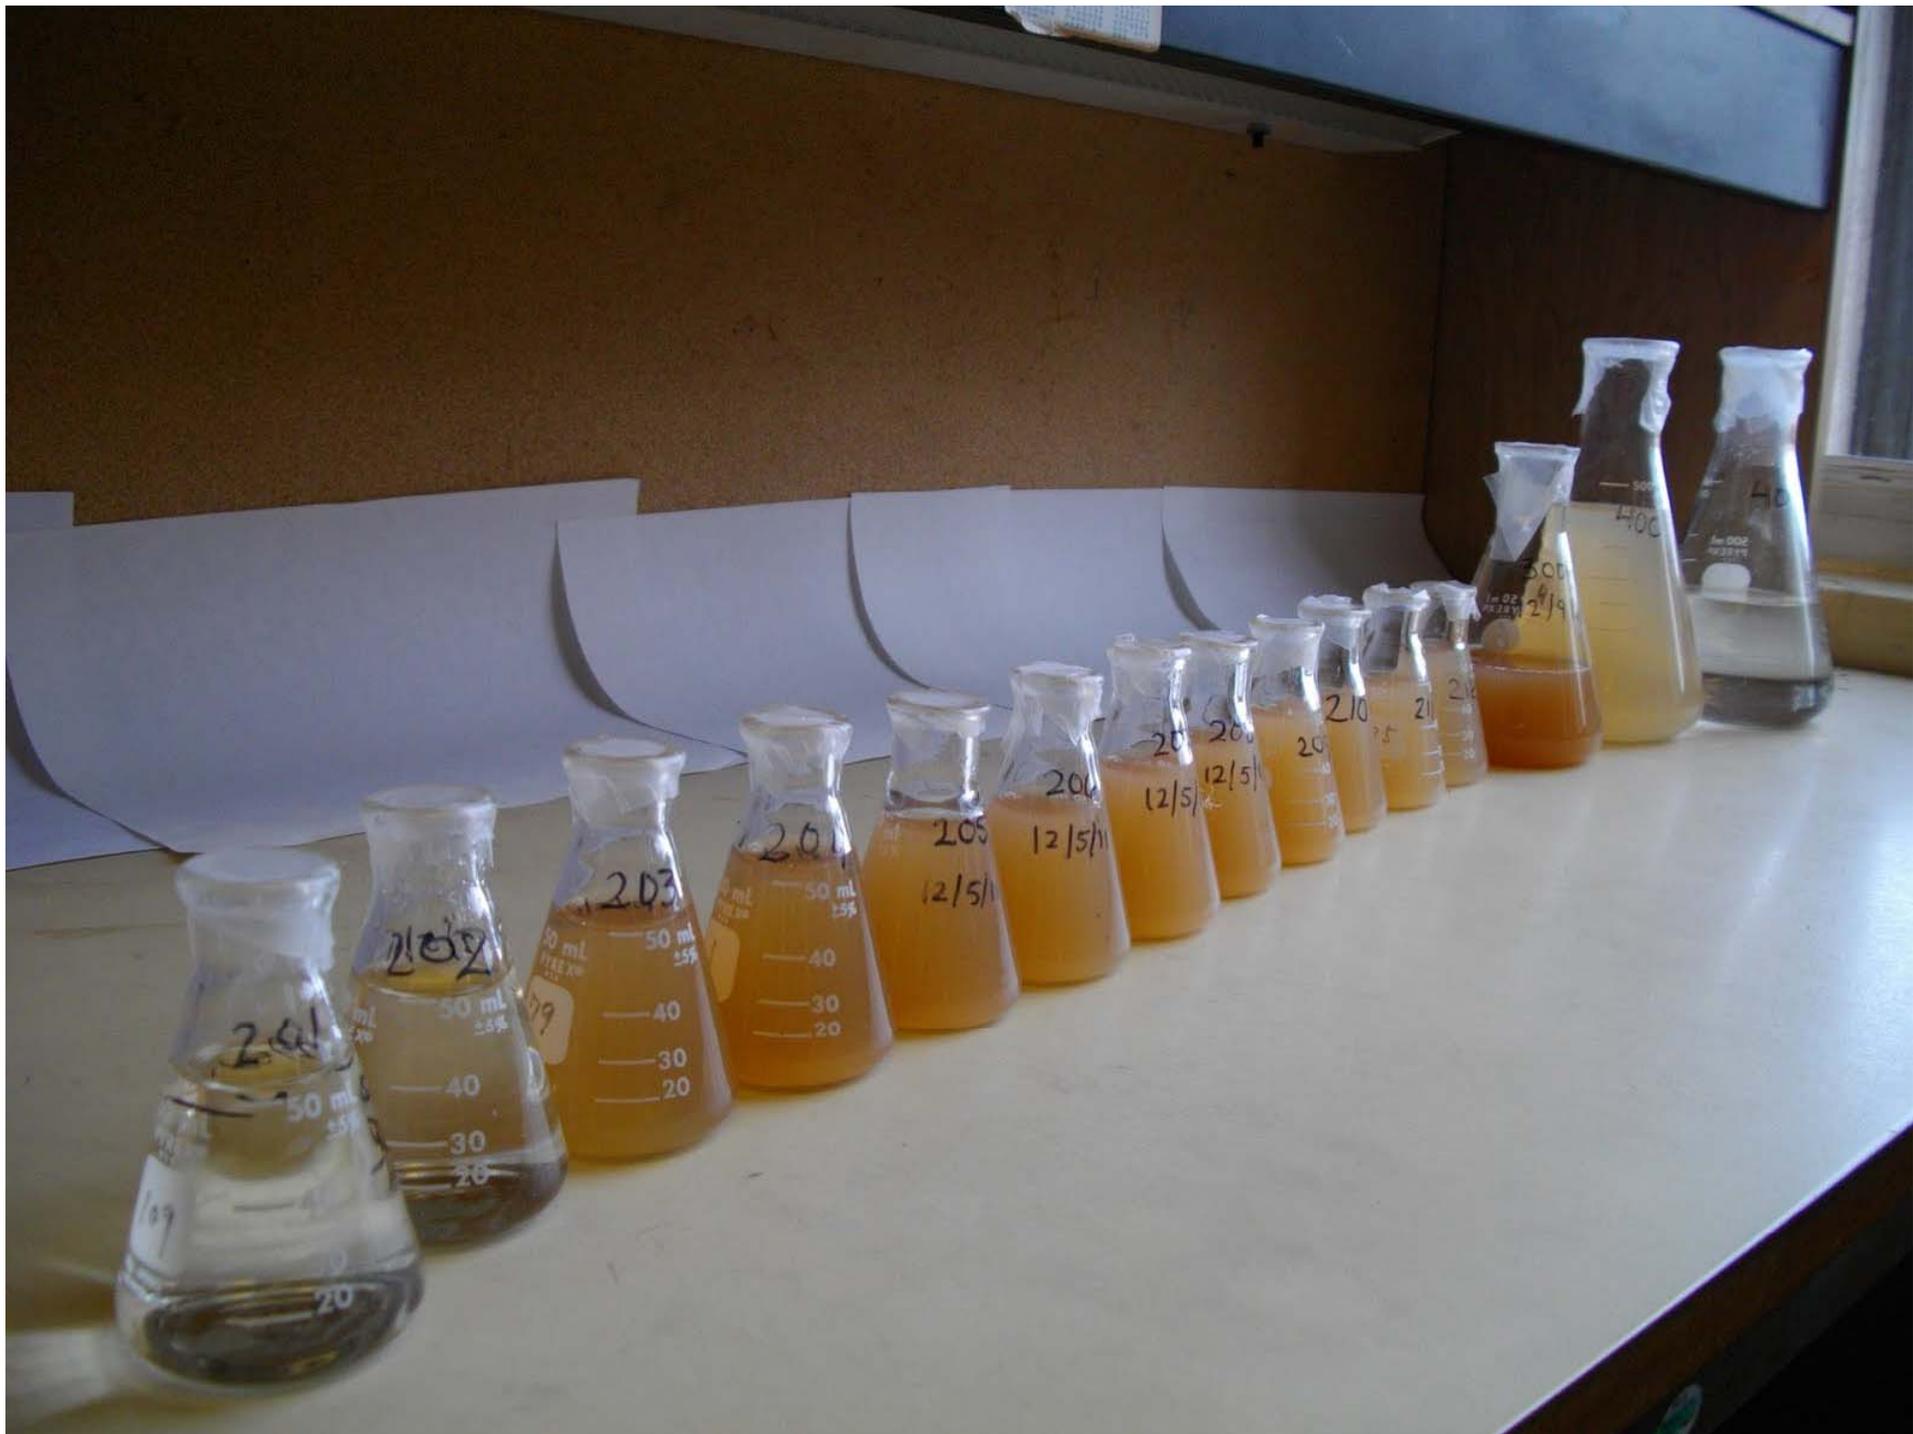
Ksat Value:	low SAR, EC	high SAR, EC	low SAR, EC	low SAR, EC	tap water
Test 1	38.7	42.1	39.9	39.6	
Test 2	34.9	32.0	19.0	20.0	
Control					32.5

## Conclusions/Questions re: sandy engineered soil:

- Hydraulic conductivity can be cut in half by sodicity; more to come later?
- More resilient to salt than engineered soil currently used in these ponds
- Sandy soil still bleeds clay when sodic; will this lead to impermeability over time if a clay lamellae forms?
- Would not something other than sodium chloride be desirable?
- How about something other than a swelling clay, such as attapulgite or biochar, to form a moisture retentive upper horizon for plant growth?
