SMALL SCALE WASTE MANAGEMENT PROJECT

Wisconsin Mound Performance

James C. Converse and E. Jerry Tyler

1986

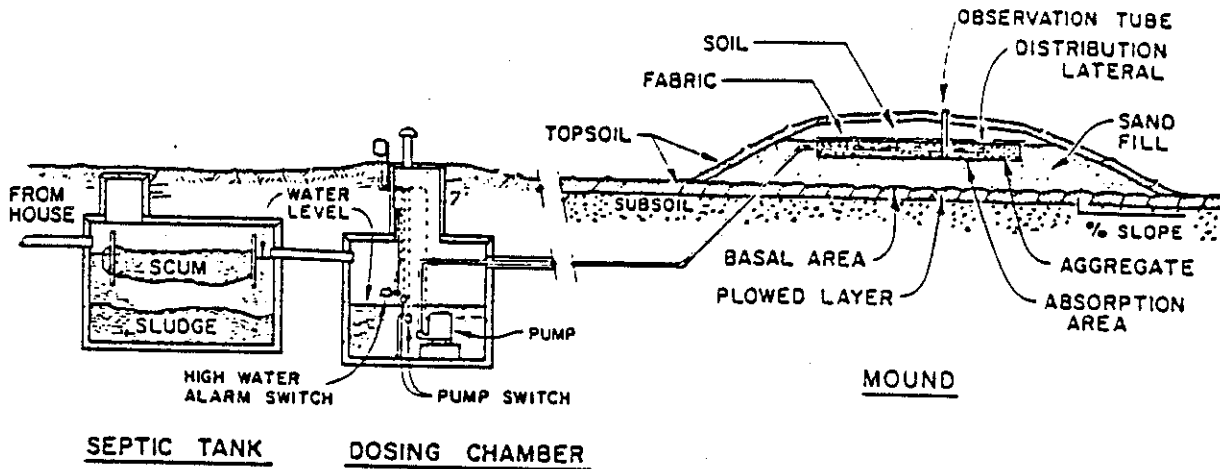
Figure 1. Components of the Wisconsin Mound System

The mound system, consisting of a septic tank, dose chamber and mound, is shown in Figure 1. The mound is constructed with a medium sand, which is placed on the tilled natural soil. Within the fill is an absorption area (bed or trench of aggregate) and a pressure distribution network. The fill beneath the absorption area and the natural soil provides the necessary separation distance for treatment prior to the effluent reaching the restrictive layer. Arrows in Figure 2 indicate the wastewater flow from mounds for different soil-site conditions.
